DEPARTMENT OF TRANSPORTATION**DIVISION OF ENGINEERING SERVICES**

Contract #: 04-0120F4Cty: SF/ALA Rte: 80 PM: 13.2/13.9File #: 69.28**WELDING INSPECTION REPORT****Resident Engineer:**Pursell, Gary**Address:** 333 Burma Road**City:** Oakland, CA 94607**Report No:** WIR-000450**Date Inspected:** 07-Sep-2007**Project Name:** SAS Superstructure**OSM Arrival Time:** 630**Prime Contractor:** American Bridge/Fluor Enterprises, a JV**OSM Departure Time:** 1530**Contractor:** Zhenhua Port Machinery Company, Ltd (ZPMC), Changxing Island **Location:** Shanghai, China

Bridge No: 34-0006**Component:** 77, 89 and 144 meter mock-up**Summary of Items Observed:**

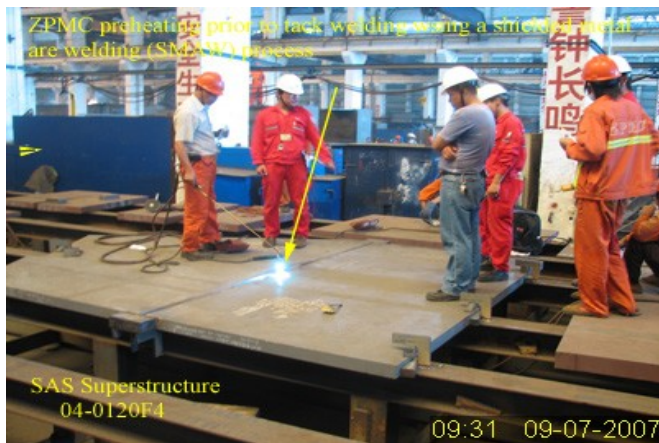
The following digital photograph illustrates ZPMC pre-heating prior to tack welding using a shield metal arc welding (SMAW) process.
